## A BUILDING SURVEY REPORT

**DATE OF INSPECTION:**                      **XXXXXX, 2011**

# SAMPLE BUILDING SURVEY REPORT

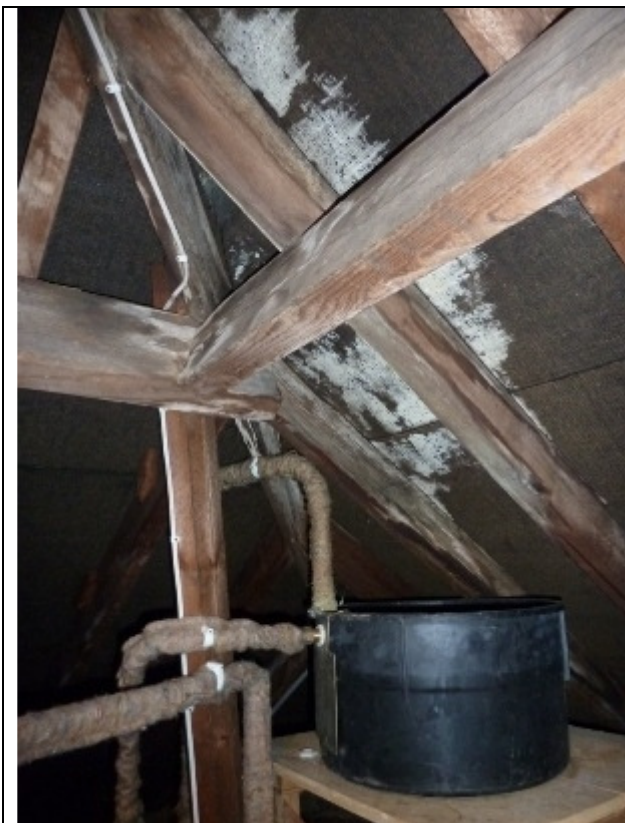
From inspection in and around the roof, the timbers appear to be in reasonable condition for their type and age. There is extensive staining to the rear hip, directly above the feed and expansion tank serving the central heating system. The sarking felt is also rather stained and this suggests that the boiler has been overheating, forcing steam back through the vent pipe into the roof space and this has led to condensation occurring on the sarking felt and timbers in the roof space. The central heating system requires therefore proper servicing and adjustment of the settings to prevent this occurring on a regular basis. This also implies that the standards of ventilation to the roof space are not good and this requires improvement. It may be possible to insert proprietary eaves ventilators in the soffit boards around the edge of the roof and provided the insulation is drawn back from the eaves, this may assist in improving ventilation. If this cannot be practically achieved, the insertion of some vent slates in the roof slopes may be the only alternative and this will involve disturbing the synthetic slates on the roof. As previously noted these may incorporate a small proportion of asbestos and you will need to engage a contractor who is experienced in this type of work in order to install the ventilation.

Staining, suggesting excessive heating of the boiler primary circuit. This causes hot water to be forced through the vent pipe into the feed and expansion tank, which produces steam and condensation.

As a result, it is thought prudent that an inspection is carried out of the heating system, including the feed and expansion tank, to establish whether there is an ongoing problem with the tank or with venting of the hot water system into the roof space.

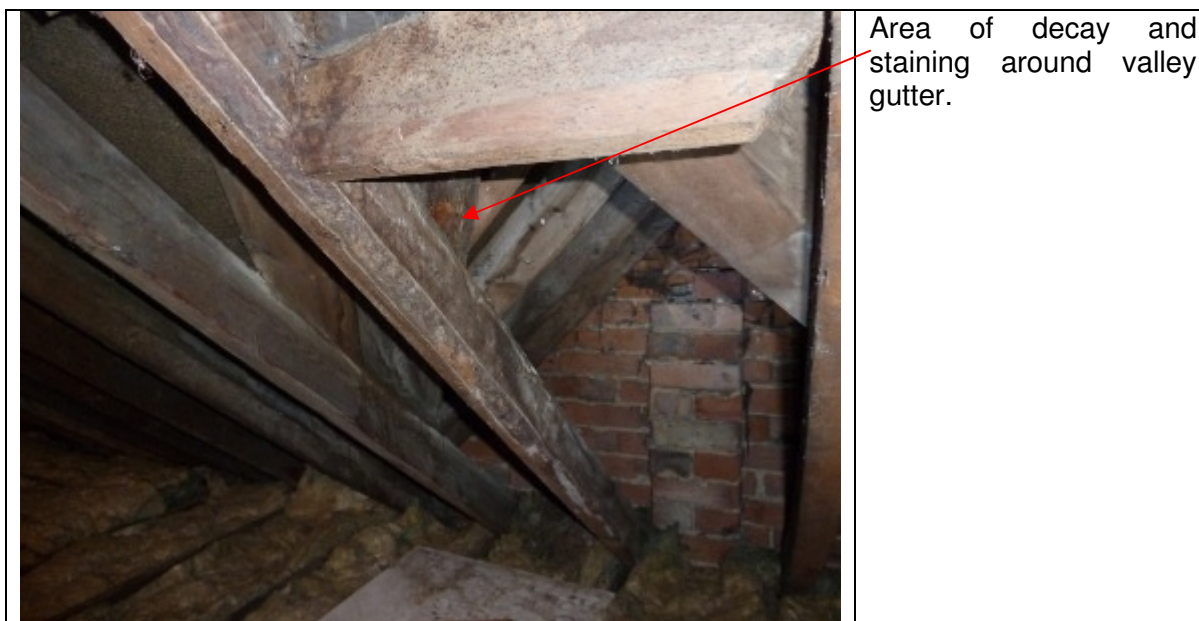
A further area of damage to the roof structure was noted where the valley boards to the front main slope appear to have become saturated, due to defects in the valley gutter linings. Decay has occurred to the timbers however this does not appear to have caused any structural damage and it is thought that this is long standing and pre-dates re-covering of the roof with the current synthetic slates and lead valley linings. The prolonged period of dry weather recently experienced results in reducing the evidence of leaks and penetrating

dampness in such circumstances and it cannot therefore be fully confirmed that the roof covering is fully watertight around the valley.

As previously noted, there are signs of past decay to one of the valley boards visible within the main roof space, to the front slope. This was dry when touched and there are no signs of an ongoing problem; it is thought that this decay occurred prior to replacement of the main roof coverings and is therefore currently inactive. The decay appears to be limited to the valley board and is not affecting the performance of the main structure.

You may however wish to obtain a second opinion on this matter and because you will be instructing a specialist to inspect the property in relation to dampness, it may be prudent to ask for a second opinion on this decay noted in the roof space.

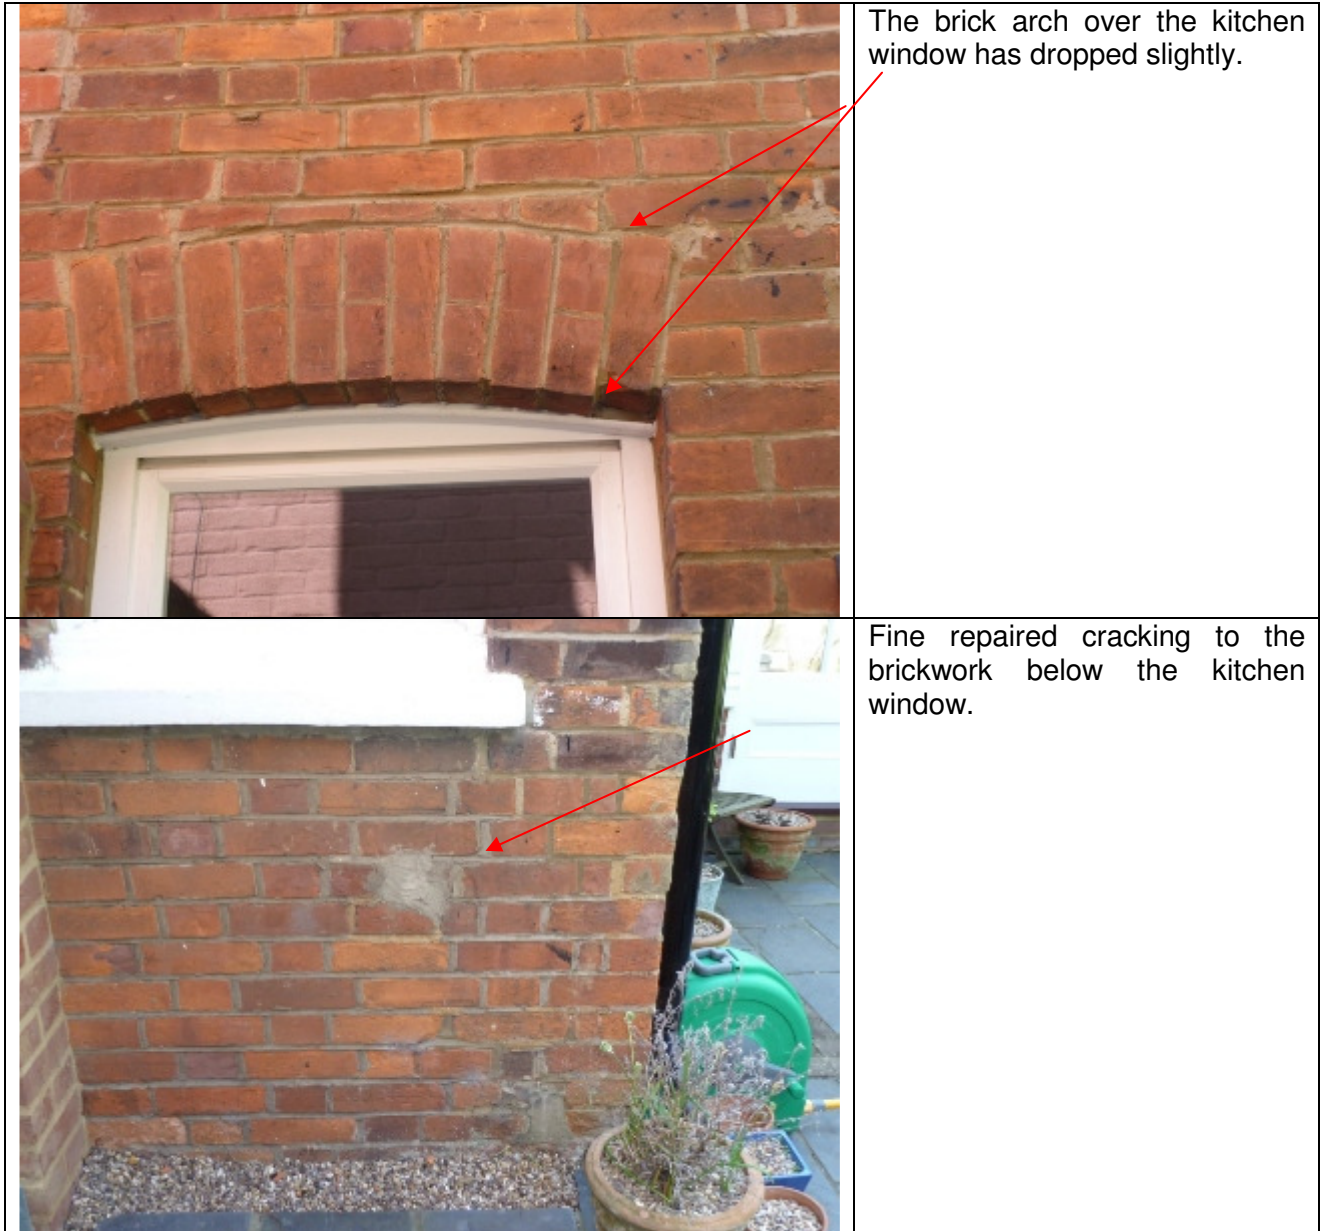
The front gable wall appears to be half brick thick, reinforced with a 9" pier to the centre, visible within the roof space (see picture above). There are a number of open brick joints to the apex of the gable and although apparently currently stable, some repair work and re-pointing may be required in due course. The front elevation generally shows evidence of need for localised patch repairs to pointing; the flank and rear walls appear to have been re-pointed throughout in recent years.

The brick arch over the kitchen window has dropped slightly, this has been re-pointed and there are no signs of subsequent movement. There is some vertical cracking beneath the kitchen window, and again this has partly been re-pointed but the cracks although fine, remain. The brick arch over the kitchen back door opening has dropped, has been re-pointed and appears to have moved slightly again. These signs indicate that the rear right hand corner has moved outwards slightly and this is probably a consequence of having two openings in the walls so close together. The main drainage runs around this corner and there is potentially a risk that drainage may be contributing to movement; leaking drains tend to wash the ground out from underneath foundations. There does not appear however to be significant downward movement of the brickwork in this area, which suggests that the foundations are substantially unaffected. No works are considered necessary currently however this part of the building should be monitored just to ensure that movement does not recur. Such problems with houses of this age are quite common and the extent of movement experienced in the last 100 years or so does not seem to be extreme. Movement in brick arches can also be associated with progressive deterioration of the timber backing lintels but these are not accessible for inspection.

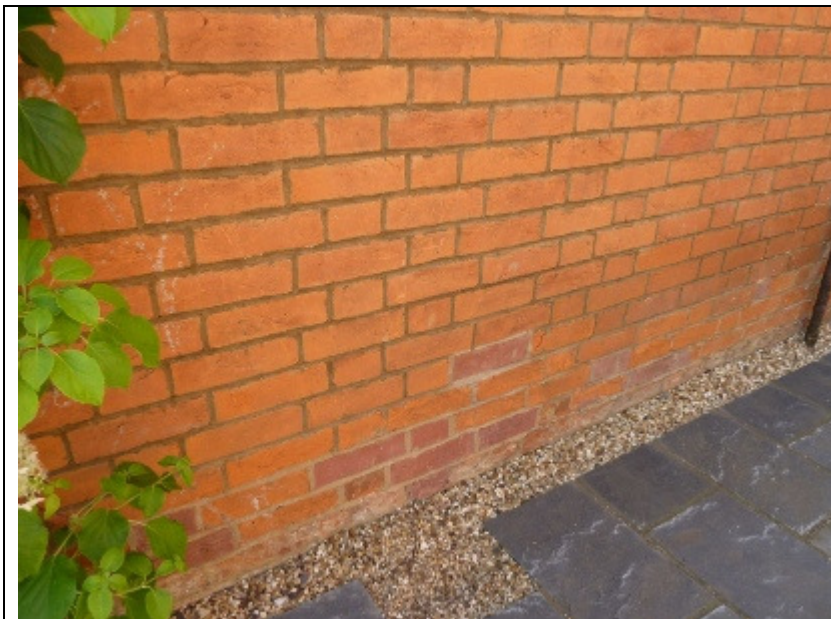
In a number of areas the ground levels encroach within this 150mm margin and, particularly along the right hand side of the property, some dampness was found internally. It is therefore recommended that ground levels adjacent to the wall are lowered to reduce the bridging effects of the damp course. In view of the high quality of the pavings in the vicinity, it is suggested that an open trench is formed along this side of the property and infilled with loose aggregate material of large dimensions i.e.: stones in excess of 30mm in diameter, which will prevent capillary action against the brickwork, which can lead to bridging of the damp course.

High ground levels against the right hand flank wall.

Ground floor walls were tested with an electronic damp meter at regular intervals (except where furniture, etc, prevented access). A number of high damp meter readings were obtained along the right hand wall internally and on the rear wall return within the kitchen. The highest of these was obtained within the understair cupboard at about 40% wood moisture equivalent (WME). The kitchen units prevented access to the rear section of the flank wall and may conceal dampness problems. Where accessible beneath the kitchen sink, the wall plaster visible is of a hard cement based render and this was found to be entirely dry when tested. It may not be reasonable however to assume that the same plaster finish has been applied along the full length of this wall within the kitchen.

It is thought likely that this dampness is largely associated with elevated ground levels along the right hand side of the property and it is therefore strongly recommended that the ground levels are lowered to finish 150mm below the level of the damp course, and that the walls are given an opportunity to dry out. As a rule of thumb, it is considered that every inch of brickwork takes a month to dry out and therefore a 9" wall of this type will take at least 9 months to dry in good conditions. The older plaster finishes internally however may now be contaminated with hygroscopic salts (salts that will absorb moisture from the atmosphere and retain dampness) and as a result, some re-plastering may be desirable internally. Given the extent of the dampness and the likely disruption that could potentially follow from the extent of works required, it is recommended that you obtain a quotation from a competent damp proofing contractor, either a member of the BWPDA or the Property Care Association. It is possible that the best approach would be to tackle the ground levels first and wait to see how much the walls dry out in the first 1-2 years, prior to tackling any significant repairs works internally. As with any dampness, there is however an associated risk of potential decay to timbers adjacent to the outside walls and these factors must be balanced when considering the timing and extent of works.

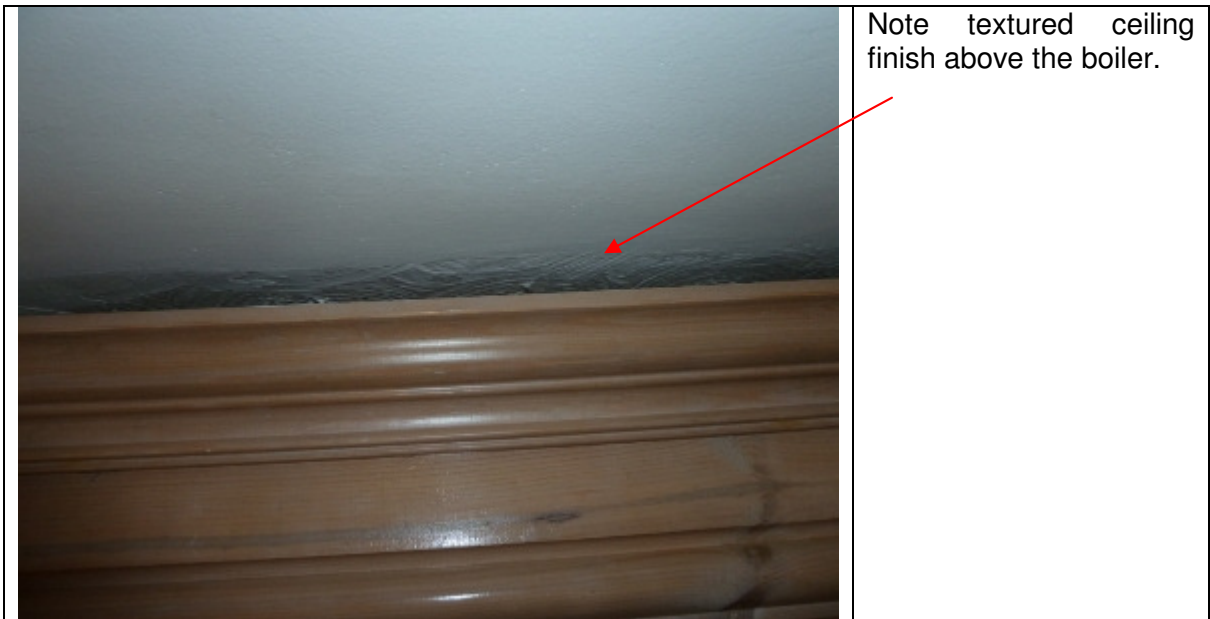
Many of the ceilings appear to have been over-skimmed in recent times and a number have had plaster covings installed around the perimeter. An inaccessible part of the ceiling in the kitchen, above the boiler installation shows that this ceiling has been plaster skimmed over earlier Artex type finishes.

The Artex coatings may contain a small percentage of asbestos in their composition. Accordingly, these surfaces should not be disturbed by drilling, sanding, or otherwise worked in such a way as to generate dust as this causes a hazard to health. The extent of original Artex finishes to ceilings is unknown and therefore care must be taken when working on any of the ceilings in the property.

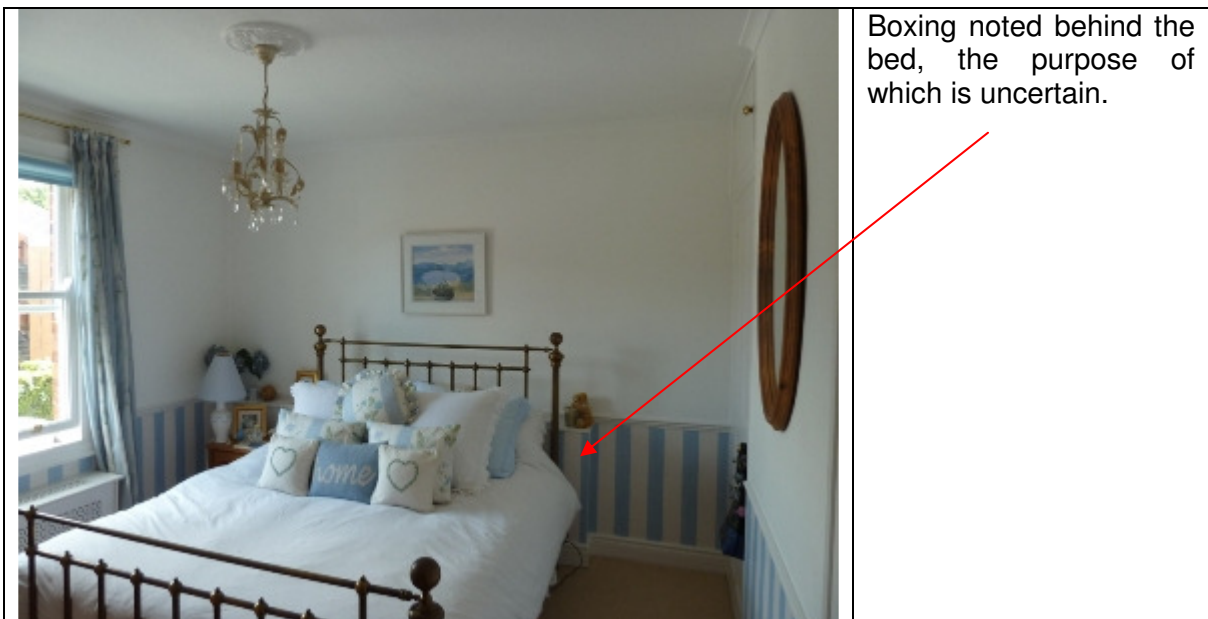
Within the front bedroom there is a half-height boxing along the party wall. The purpose of this boxing is unknown; the vendor stated that it appears only to be there to act as a shelf for the bed. If this boxing is removed, concealed defects may become apparent.

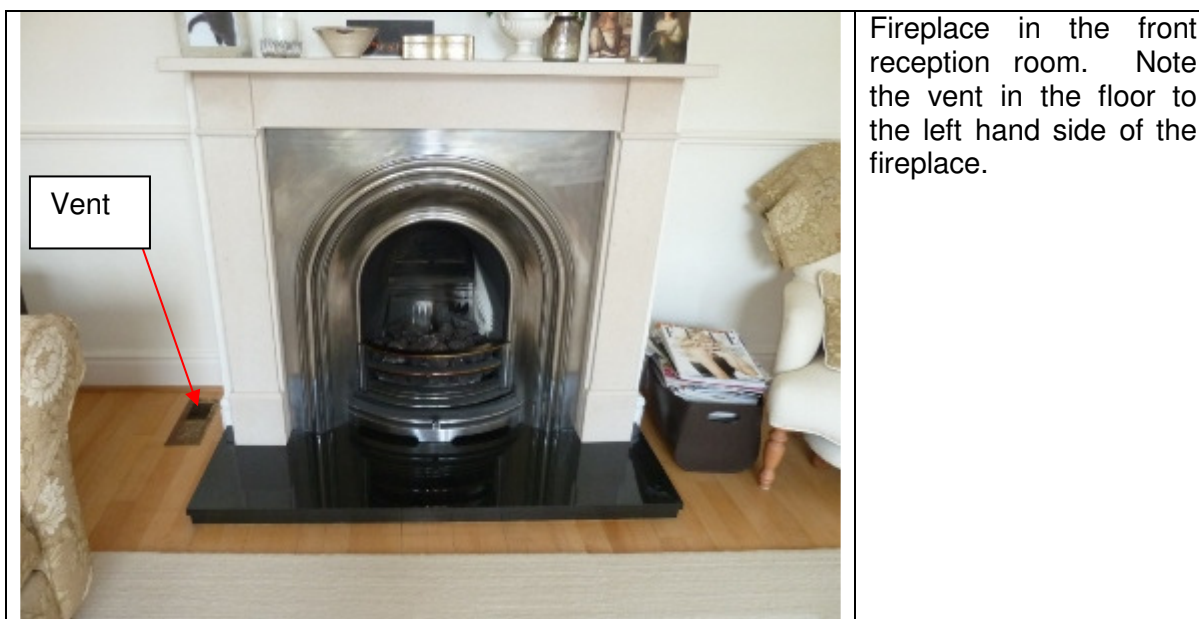
A fireplace is retained in the main front reception room and it is understood that the gas-coal effect fire, fire surround and fire back were installed in 2007 and that there is a Corgi certificate available for this installation. A vent has been installed in the floor to the left hand side of the chimney breast presumably to permit some combustion air for the gas fire.

Flues could not be examined internally and it is recommended that all flues be swept prior to use. There are no service records of this gas fire and therefore you should instruct a Gas Safe registered contractor to inspect and service this fire prior to use.

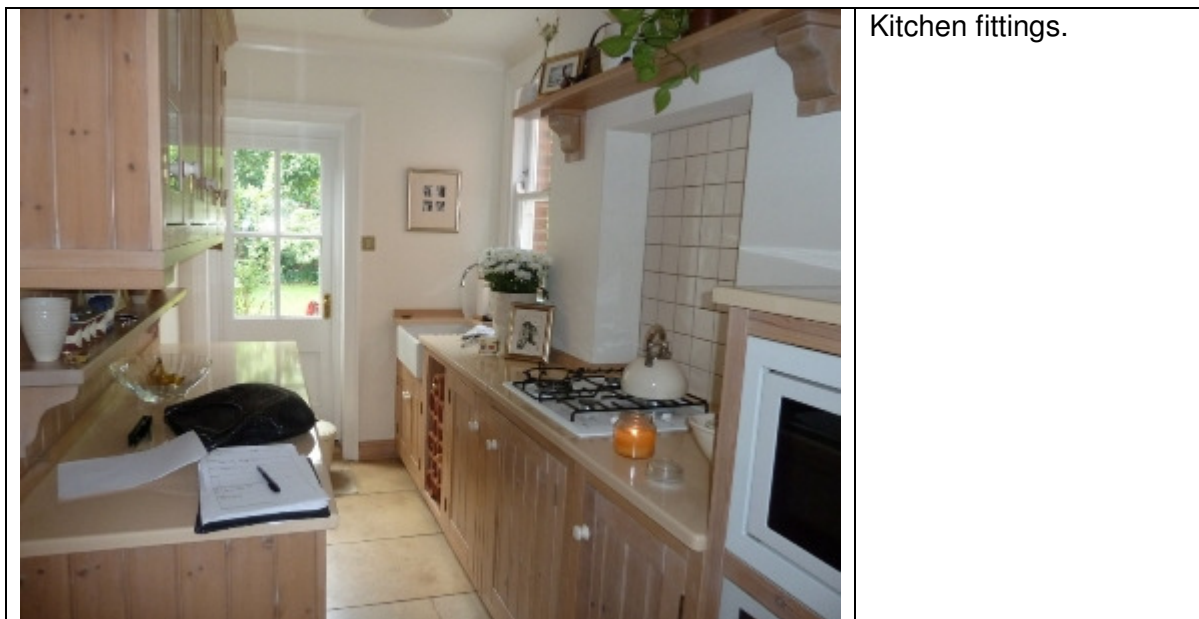
Fitted cupboards and units within the property generally appear to be in satisfactory overall condition where available for inspection and testing. There is some damage to the kitchen sink base door knob and you may wish to replace this.

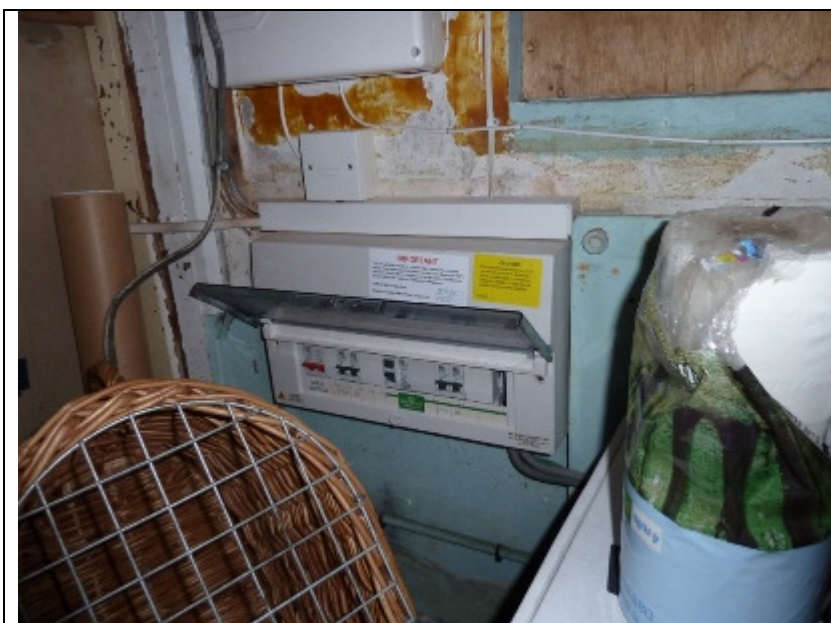
lighting is to be achieved in these rooms. The immersion heater is wired to a 13Amp plug, which is not good practice.

The consumer unit in the under stair cupboard.

In the absence of a comprehensive test certificate covering the entire property you should arrange for a competent electrician to inspect and test the system on your behalf prior to occupation of the property. Current advice from the Institution of Electrical Engineers is that domestic electrical installations should be tested every five years.

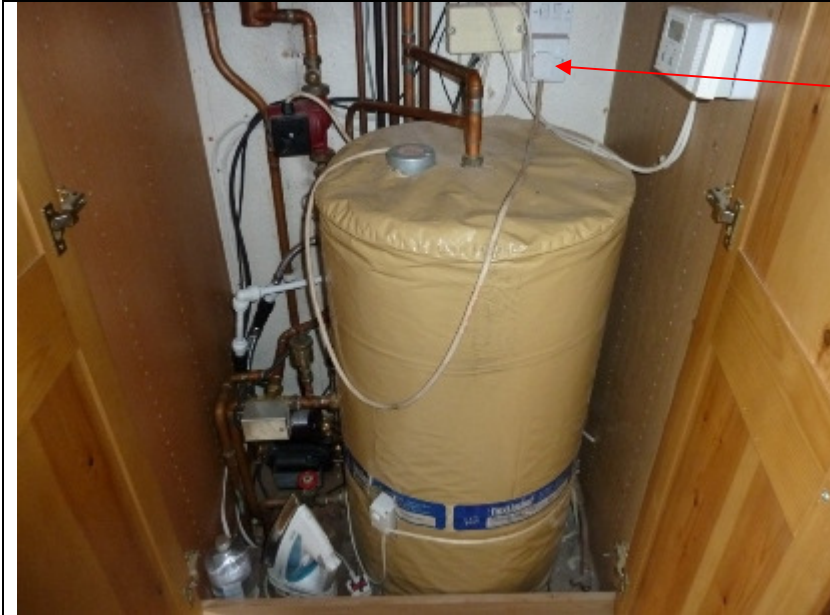
Hot water is provided by the Baxi gas fired boiler in the kitchen and is stored in a cylinder in the rear bedroom airing cupboard. The cylinder has a factory made insulation jacket which restricted the inspection. A supplementary electric immersion heater is also installed, which is wired to a 13amp plug. This is not normally considered to be good practice and a dedicated supply should be installed to service the immersion heater.

Hot water cylinder. Note the immersion heater is wired to a 13 Amp plug.

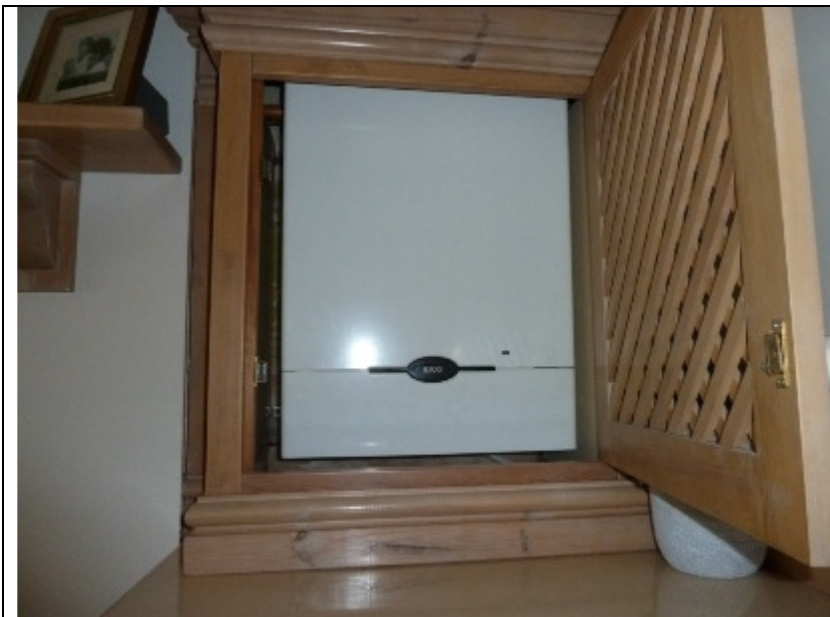
Space heating is provided by the Baxi gas fired boiler located in the kitchen, which serves a system of radiators around the property. It is understood from the vendor that the boiler was installed in 2002 and was last serviced in March 2011. The boiler is largely concealed within a cupboard in the kitchen and the radiators are also concealed by radiator boxes around the property. This will restrict access for servicing.

Baxi boiler in the kitchen.

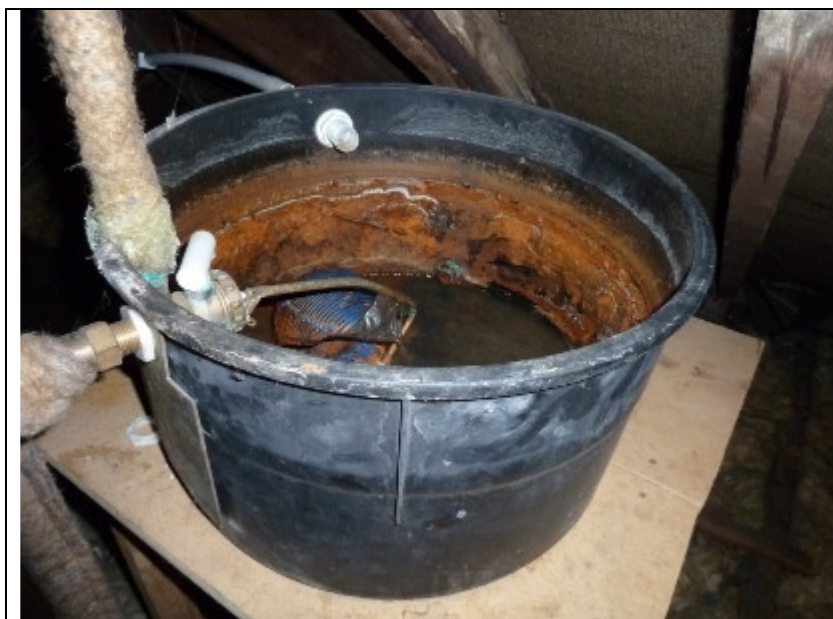
As previously noted there are signs of excess venting of the boiler into the roof, suggesting a problem with a thermostat or running at too high a temperature. The feed and expansion tank is also badly scaled and the water level very low; from first inspection, it was thought that this tank was obsolete, however the type of boiler installed does not appear to run on a pressurised system and no pressure vessel was noted within the property, suggesting that the feed and expansion tank is still in service.

Feed and expansion tank in the roof space.

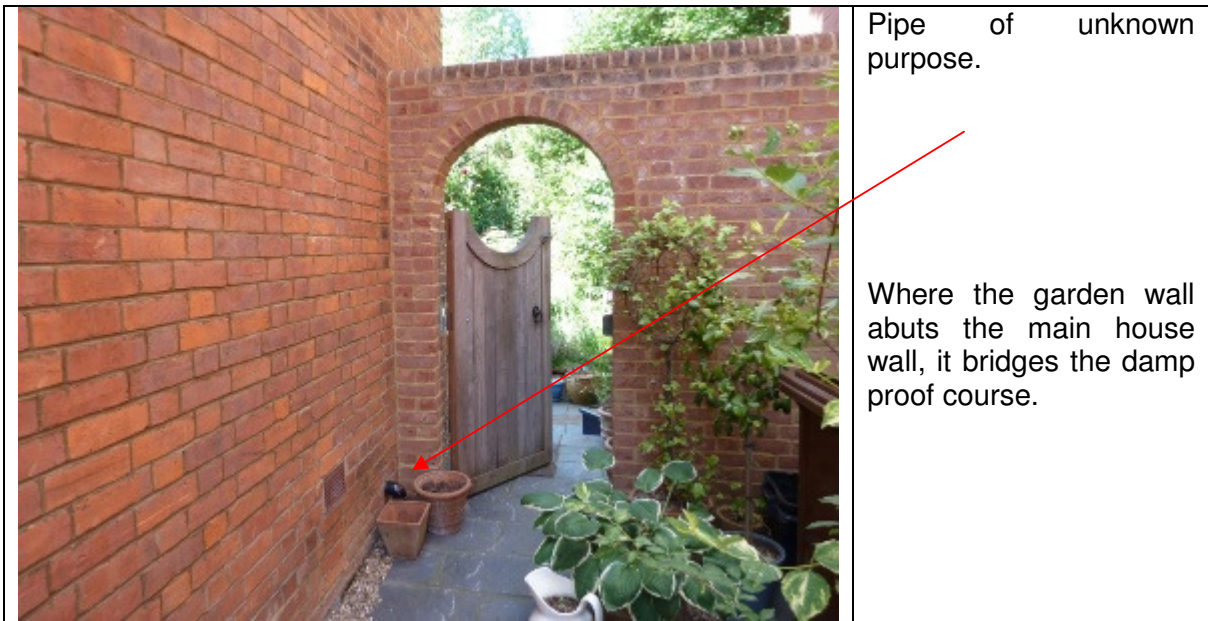
Above ground drainage to the property comprises a plastic soil pipe to the rear of the property and a number of plastic waste pipes, all of which appeared to be in generally satisfactory overall condition. There is a small section of 3" pipework visible to the flank wall, the purpose of which could not be established from inspection. This appears to discharge into the drainage system, however may allow smells to escape form the drains and appears to serve no useful purpose for the house currently. It may be therefore prudent to cap this pipe off or remove it completely.
